EDINBURGH BUS STATION Interchange Audit

Linking cycling with
public transport

Purpose of the Interchange Audit

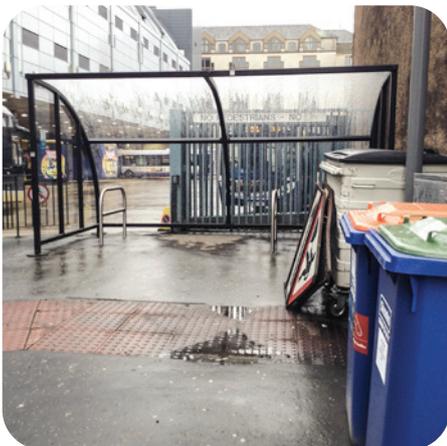
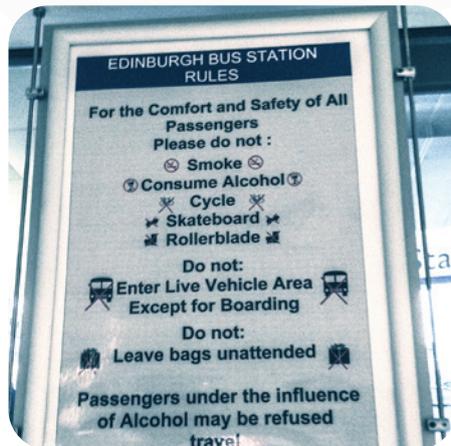
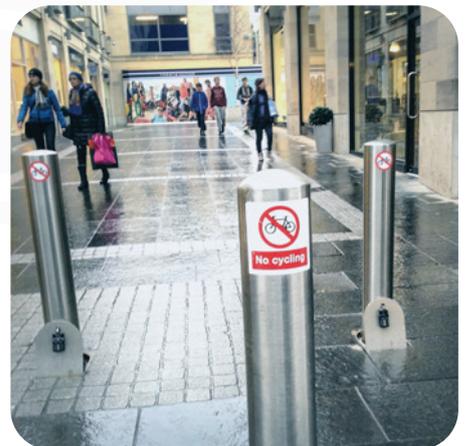
- ▶ When approaching the station from York Place, in either direction, there were no signs noting the need to turn up Elder Street to get to the bus station.

- ▶ There were a plethora of signs on either end of Multrees Walk stating cycling was not allowed. This is a 'private street' and so change will require coordination with the Multrees Walk owners.

- ▶ At the Elder Street entrance, there were four different signs for the bus station. However, there were no signs telling cyclists which routes were best for them to take, both in terms of entering the bus station or negotiating the area.

- ▶ When approaching from North Saint Andrew Street at York Place and Queen Street, there were no signs here for the bus station; there was a sign for National Cycle Route 75.

- ▶ Once at the entrances to the station, there were no signs directing you to the cycle parking, but the parking area had just been installed a few days previous to the audit.

- ▶ There was clear signage that cycling in the station was not permitted.

- ▶ Further up Elder Street from the bus station entrance there were 12 Sheffield stands, well-spaced but uncovered. The natural surveillance was good during the day but potentially not great at night once the St. James Shopping Centre was closed. The CCTV did not appear to cover the stands.
- ▶ There were three covered Sheffield stands that had very recently been installed at the bus station. The natural surveillance was good as was the CCTV coverage. There was 71cm between each stand. It is considered best practise that at least 100cm is available between each stand. At the time of the audit, station staff were using the parking area as a smoking shelter.

- ▶ As no cycling was permitted on Multrees Walk, there was no convenient cycle route between Saint Andrew Square (*i.e.* the city centre) and the Elder Street entrance of the bus station which is where the cycle parking is located. The only route which did not require a cyclist to dismount was to make a right turn on to the busy and wide York Place and then another right turn onto Elder Street.

Signage was the main concern at this station and could be fixed relatively easily with some thought given to providing consistent, useful signage for cyclists. Knowing how to reach the station by the best route and where the cycle parking is located will make the most of a station which is otherwise well suited to being accessed by bicycle.
